**Exhibit No. 5**  
For Identification

## Safety Restraint Examination

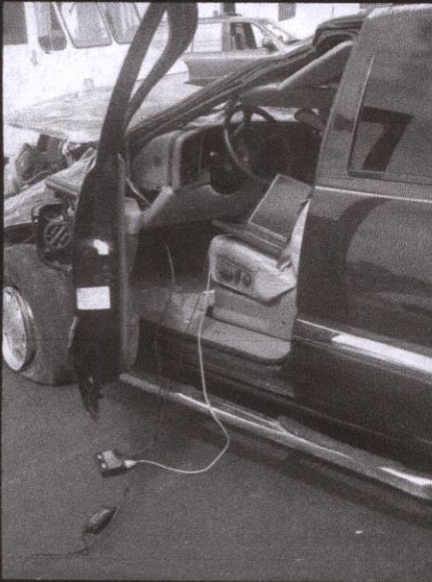
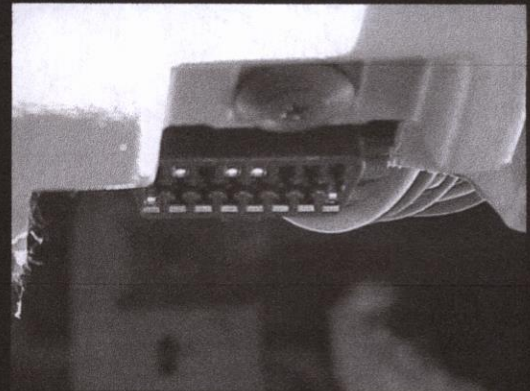
Through the vehicles Diagnostic Link Detector (DLC)

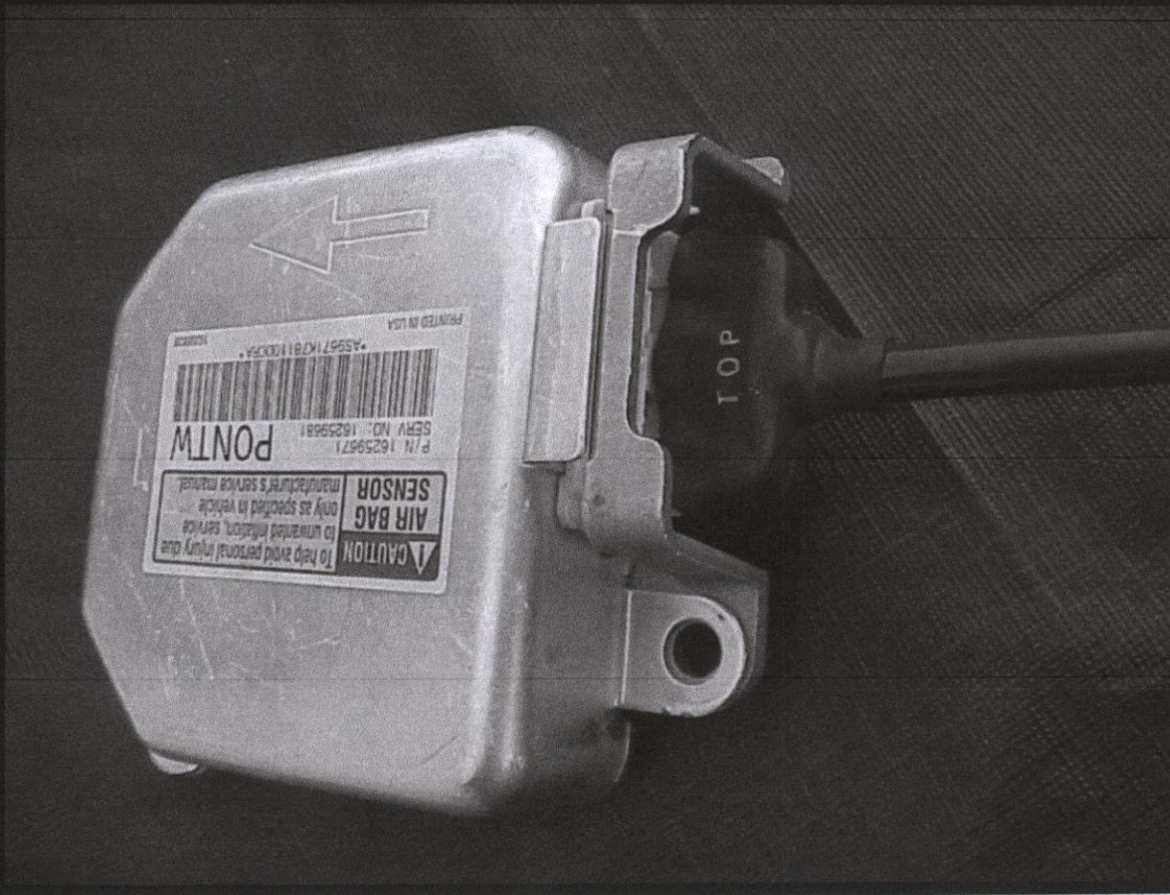
Direct to the airbag module

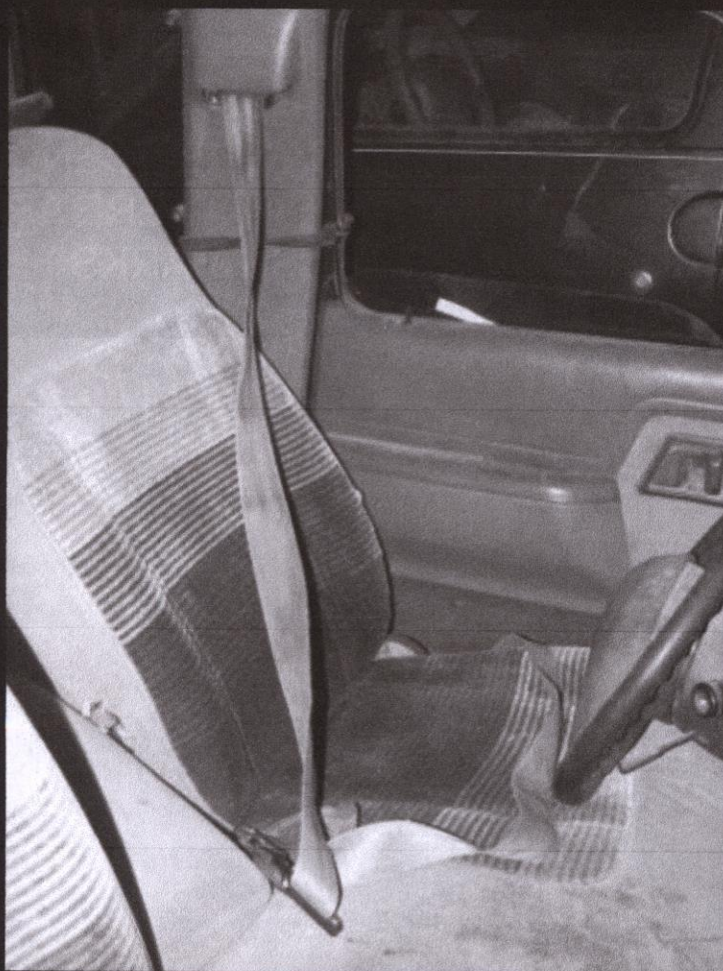
Retractor jammed with webbing extended.

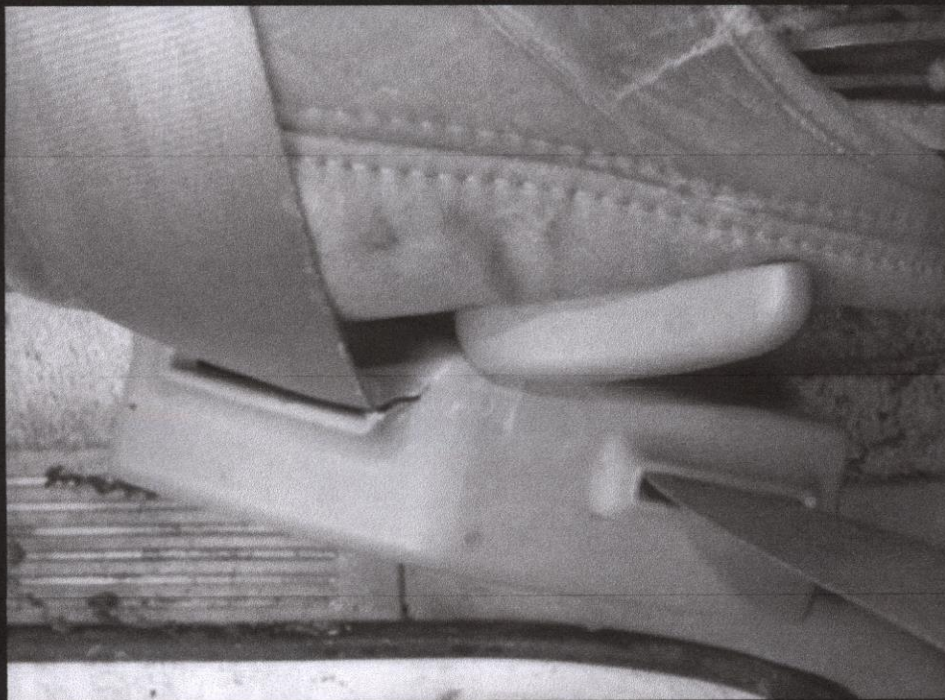
Retractor frame damaged when seatbelt load is applied.

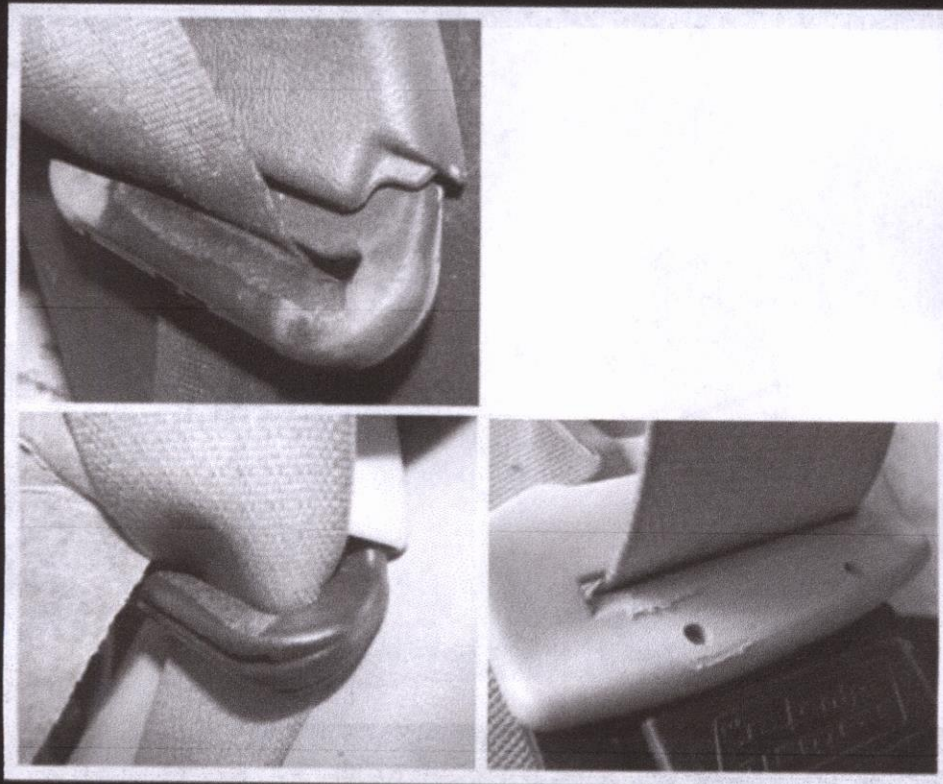
Imprint of the webbing in plastic coated parts of the restraint, such as the latch plate or D-ring. There is often a corresponding transfer of plastic to the webbing.

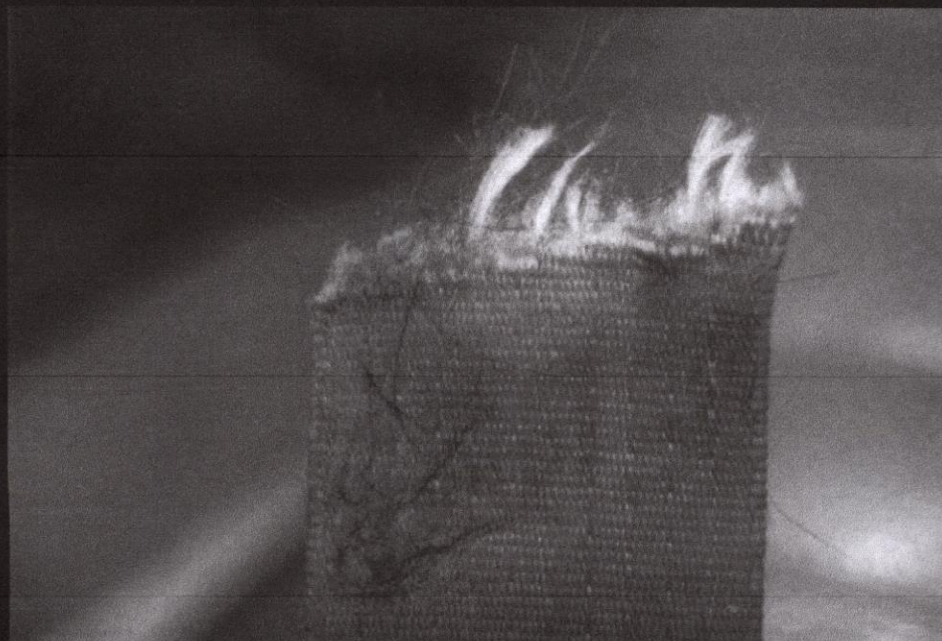
Torn or broken seatbelt webbing due to overload or a sharp surface.

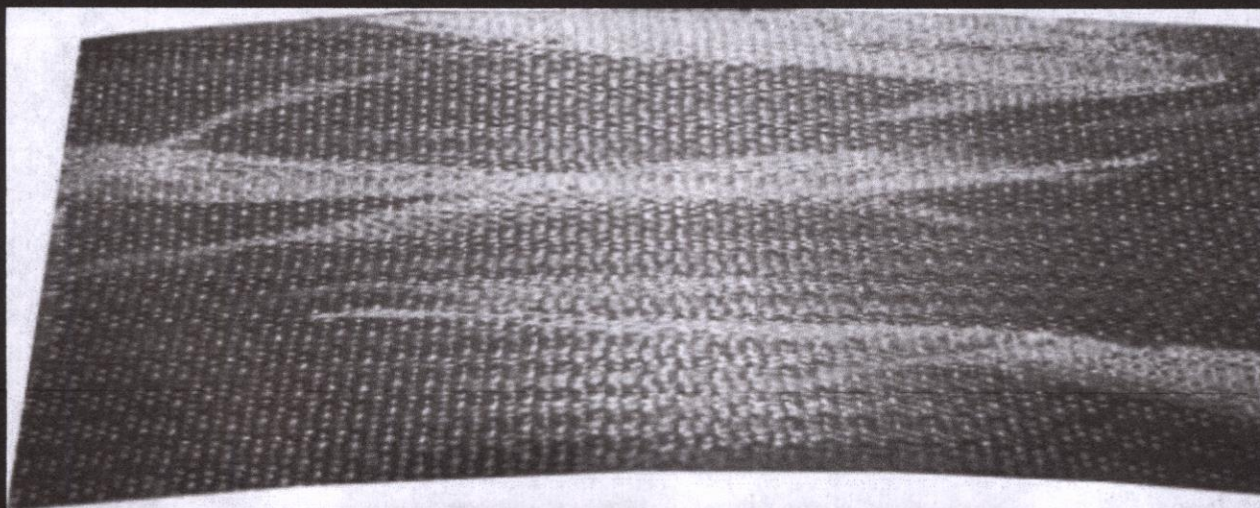
Webbing is discolored due to clothing transfer.

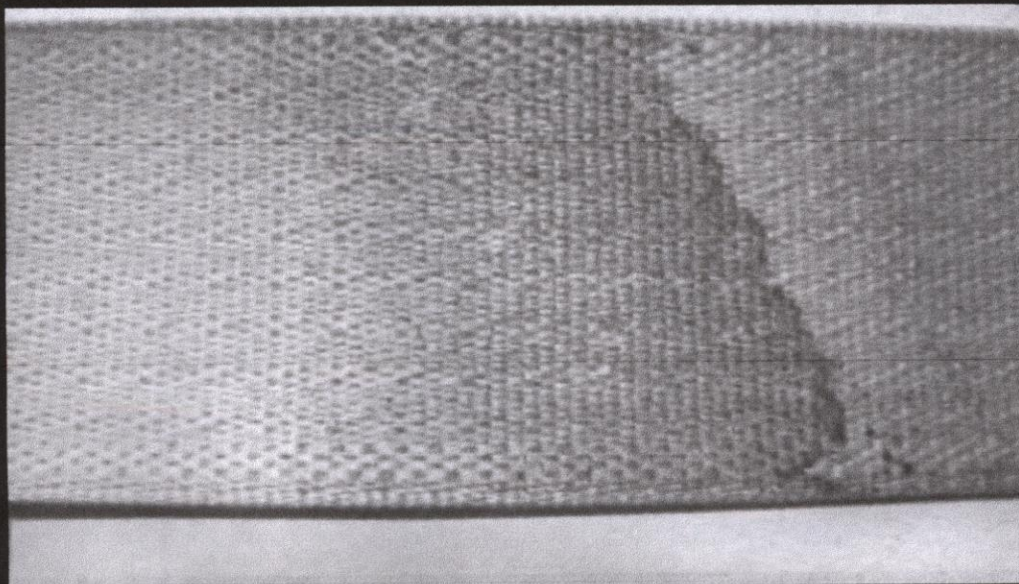
Plastic transfer from D-ring / latch plate on webbing.

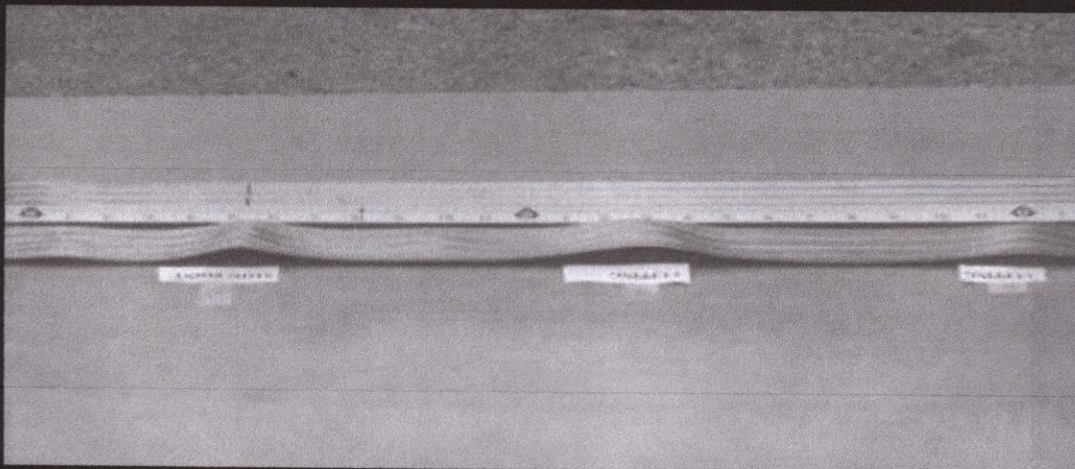
Webbing curled. (Also often called "cupping")  
This is caused from occupant loading.

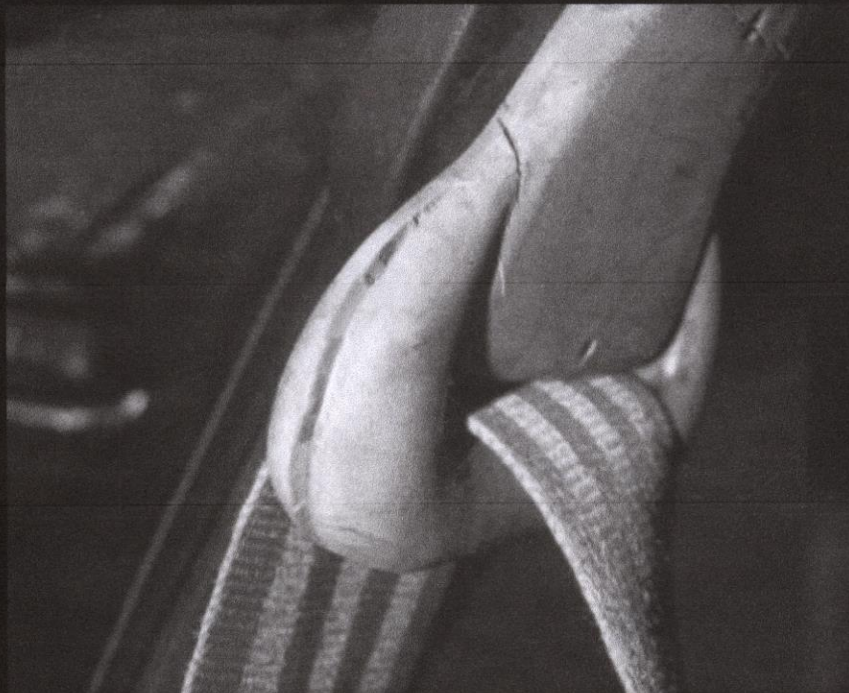
D-ring fractured due to loading.

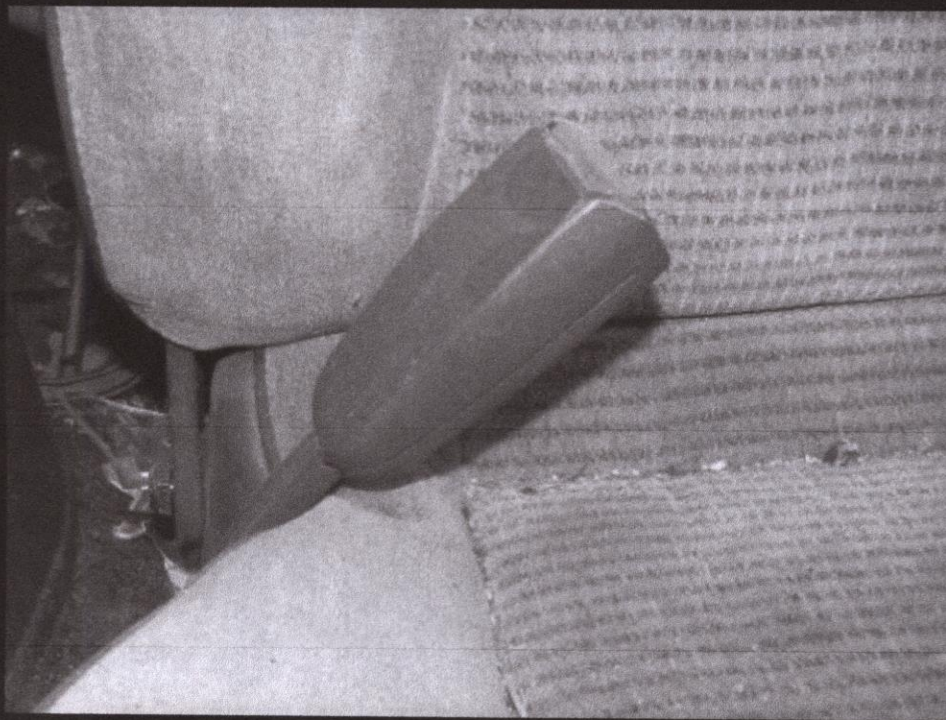
Seatbelt buckle stalk is deformed due to loading.

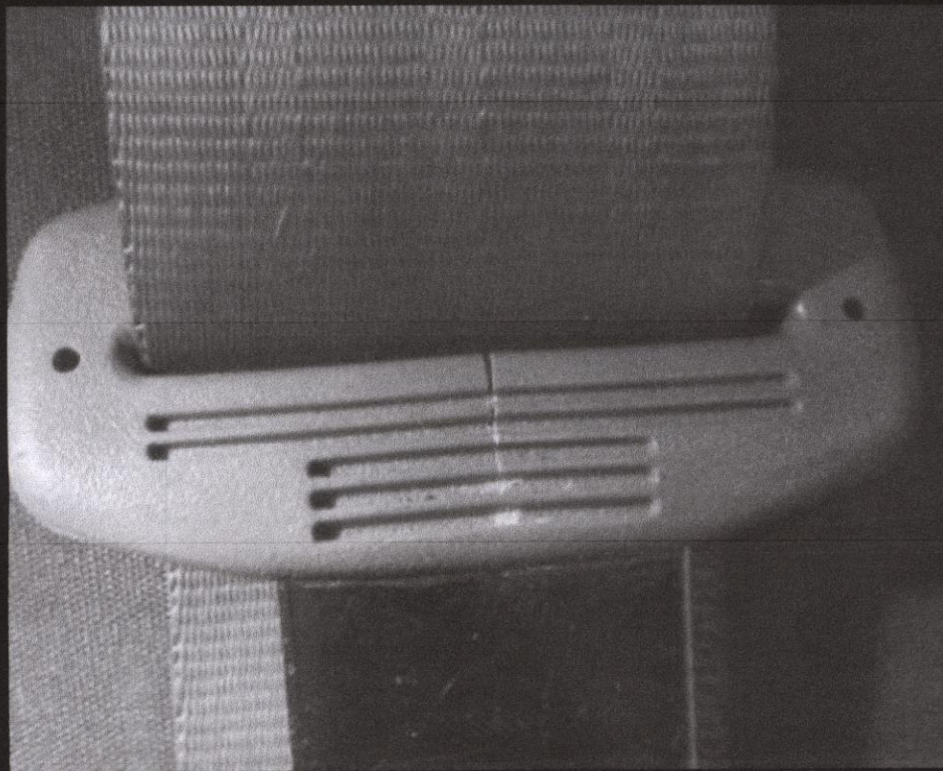
Latch plate fractured due to loading

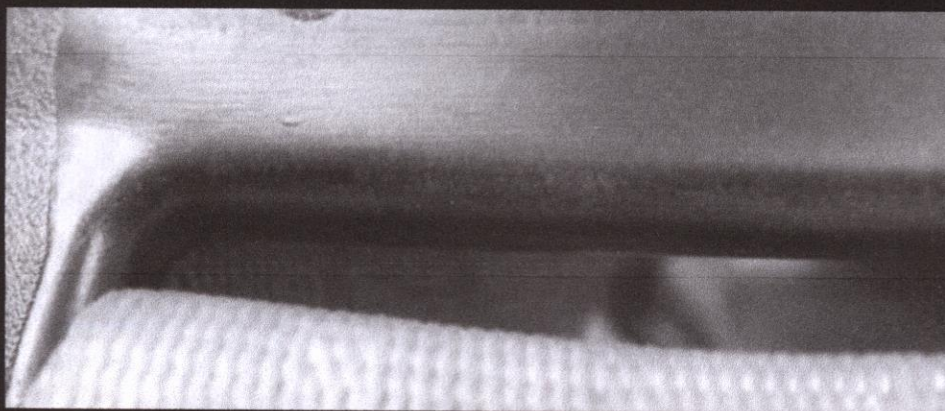
Friction marks may be visible

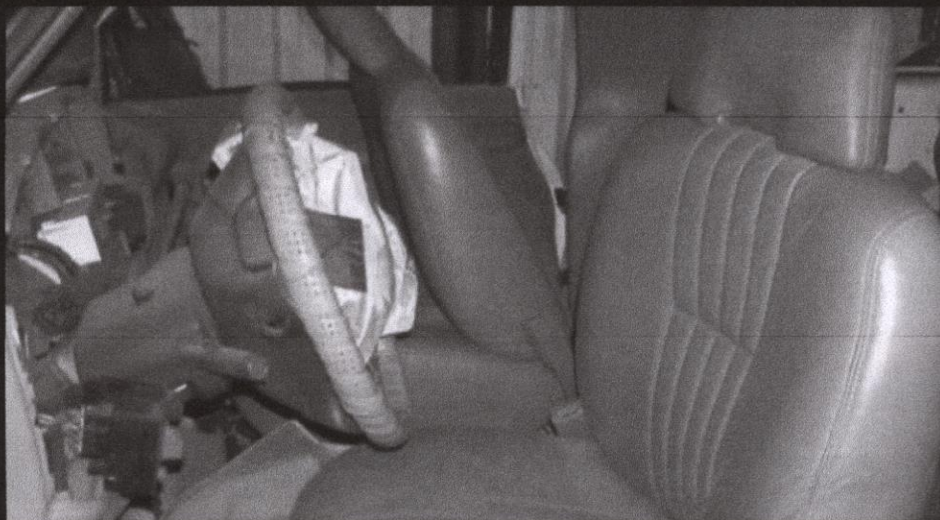
Airbag deployment prevented loading

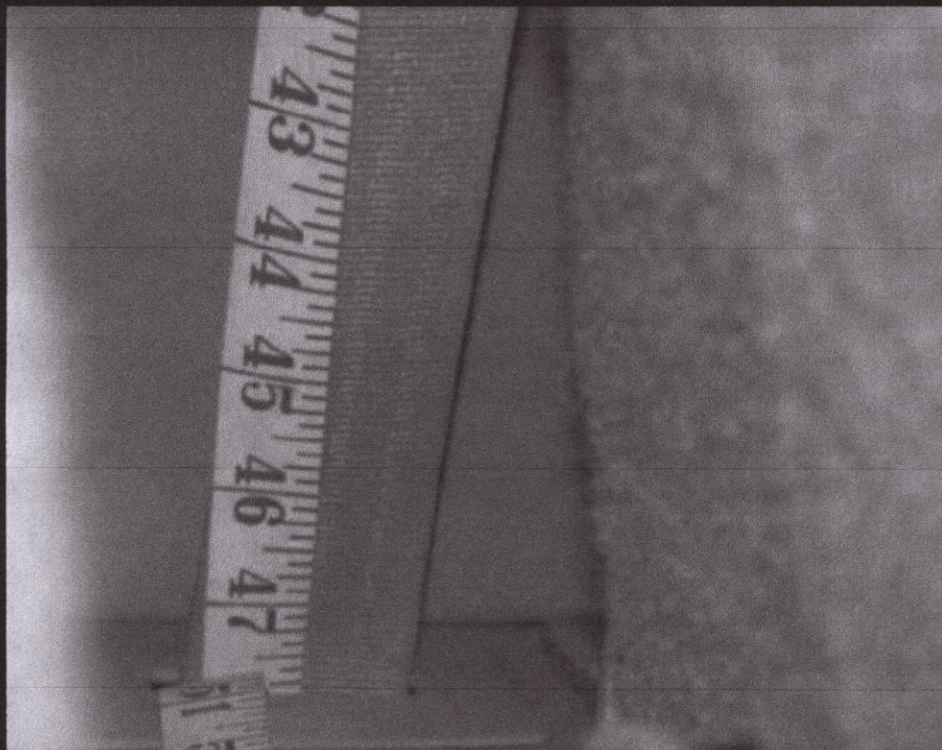
First, determine where the webbing goes into the trim such that the webbing is not exposed to the crash environment when not worn.

Measured position of a "Stowed Belt" where the belt enters the protected area inside the trim.

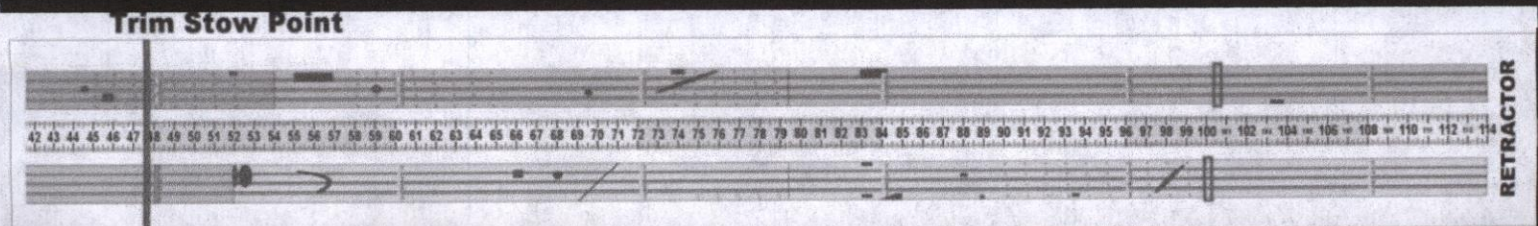
Second, inspect the seatbelt webbing at all areas below this measurement point. The photograph below shows that no piece of evidence is too small that is placed on the evidence board.

One way to document the location of belt evidence found beyond the trim panel stow point is to focus solely on the areas of the seatbelt webbing that would have been below the point where the webbing goes into the trim. If the seatbelt was not being worn when the accident began, there is little chance that damage to the seatbelt webbing beyond the trim panel stow point could happen.

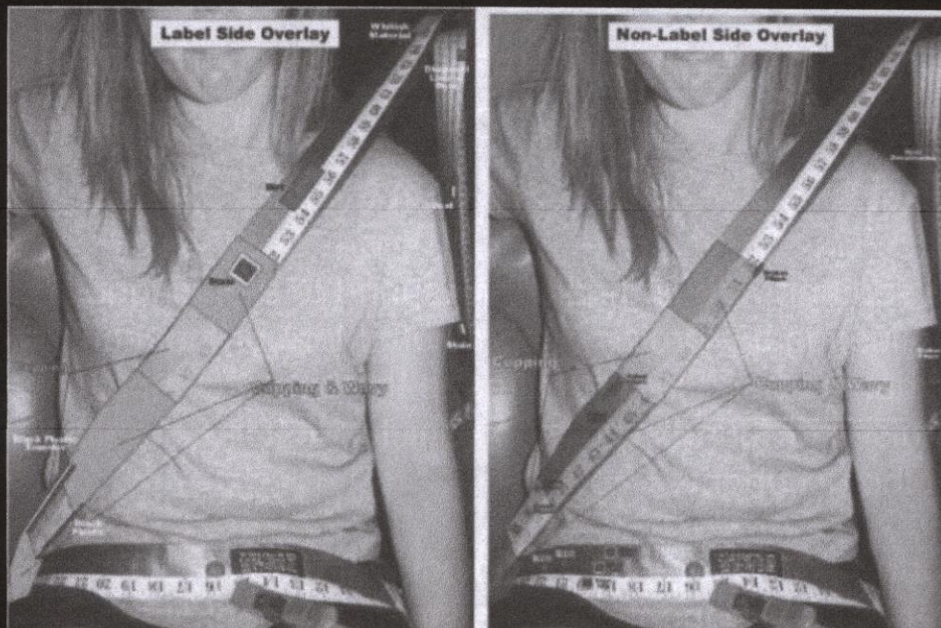
Focus on this area of the webbing  
Label and non-label side of seatbelt is laid out on a  
seatbelt evidence board that includes a measuring  
tape.

Third, document every mark, cut, dirt/stain, pulled fiber, cupped fiber and damage to the webbing on the label side and non-label side of the belt from 1 inch to the end of the belt. The technician should then transfer each cut, dirt/stain, pulled fiber, cupped fiber and observation of webbing damage onto an evidence board. The best way to accurately and thoroughly document the webbing evidence is to remove the belt and lay it out on a prepared board that has a measuring tape and illustrates the same number of webbing panels as the actual webbing.

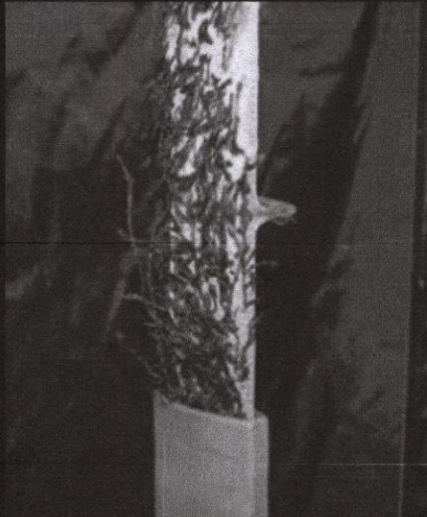
### **Expansion loops**

In an effort to favorably modify the kinematics of test dummies in barrier impacts, seat belt assembly designs often incorporate expansion loops. An expansion loop introduces additional webbing length when a predetermined level of tension is reached. Expansion loops are composed of webbing that is folded along the short axis and stitched in place

The thread material and stitch pattern used to make the rows of stitching is designed to tear at predetermined webbing tension levels, for instance around 600 to 700 pounds. When the stitches tear, the webbing fold will partially open thereby introducing additional webbing. Photograph shows the torn stitches of an expansion loop during a test.

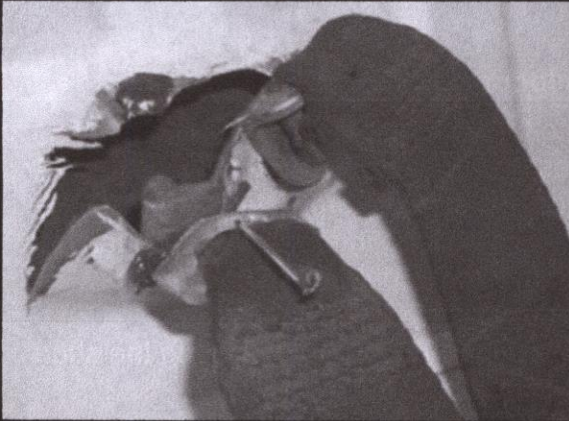
A warning label, commonly stating "REPLACE BELT," is often visible after the stitches are torn.

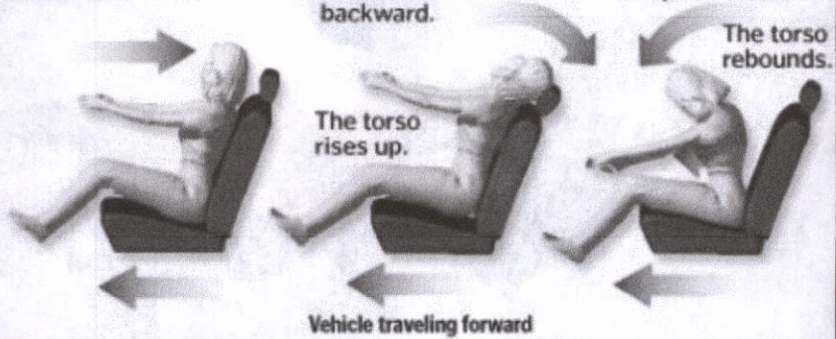
### How whiplash occurs

Motorists involved in rear-end crashes commonly experience whiplash. Injuries to the neck occur as the torso accelerates forward and the neck lags, then the head whips forward.

**1.** During normal driving, the head and torso move relative to the vehicle.

**2.** As the vehicle is struck from behind, the head tilts backward.

**3.** After the initial impact, the head snaps forward.

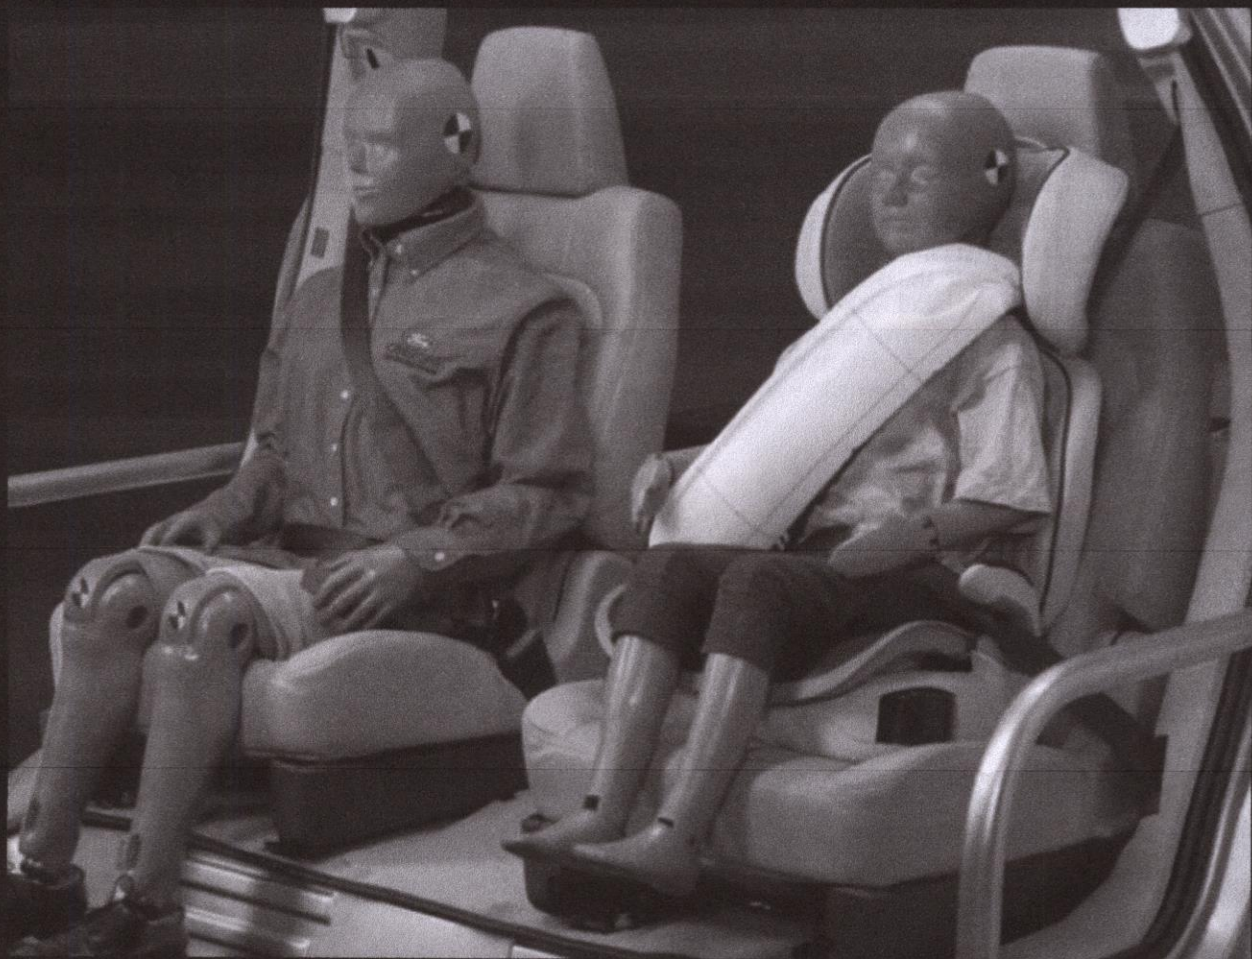
They're designed for rear-seat occupants only and, in the event of a frontal or side impact, will inflate the belt across a passenger's chest in 40 milliseconds. When expanded, the belt cover five times more surface area of the body than a normal seat belt, which helps better distribute the forces of a crash.
